# **OPERATIONS AND MAINTENANCE MANUAL**

**MISSOURI RIVER  
INDUSTRIAL PARK LEVEE  
COUNCIL BLUFFS, IOWA**

**June 2016**

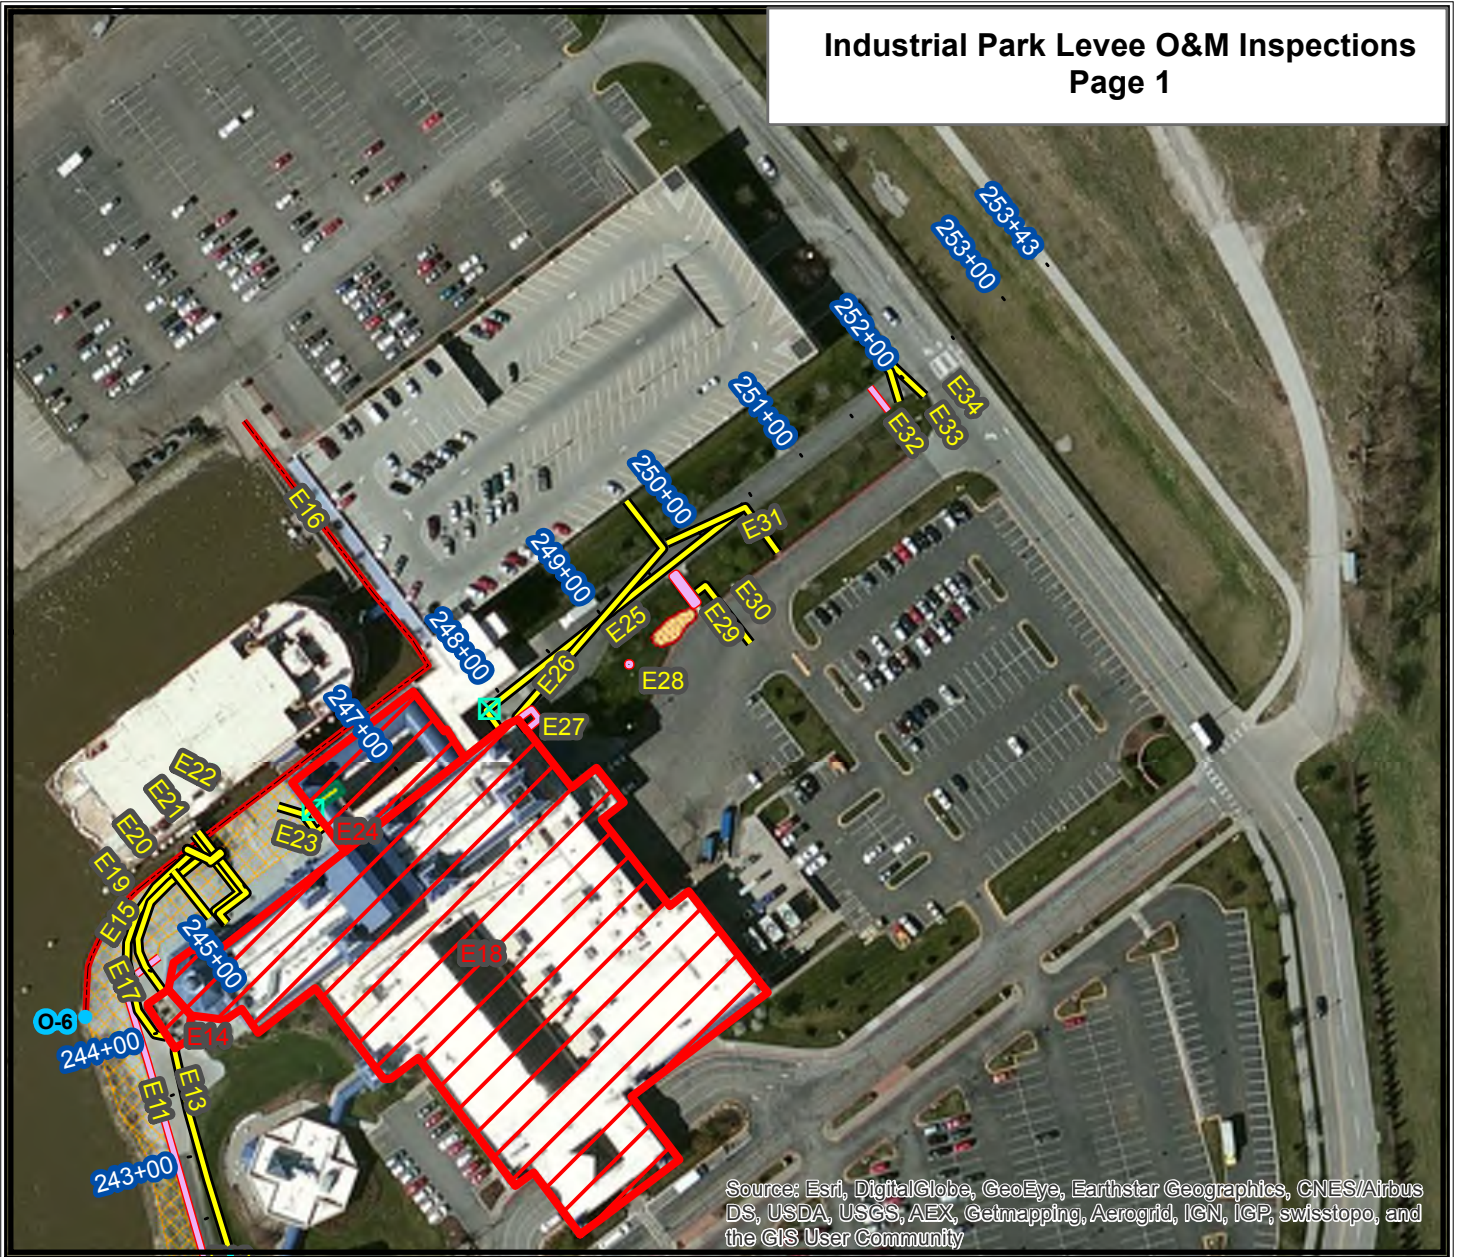
# Industrial Park Levee O&M Inspections Page 1

- Outfalls
- ☒ Drainage Structures
- ⚡ Underground Encroachment\*
- ⚡ Above ground Structure (Encroachment\*)
- Sheet Pile Wall

- ⚡ Building Encroachment\*
- ☒ Pressure Relief Wells and Monitoring Wells
- ☒ Sump
- ☒ Riprap

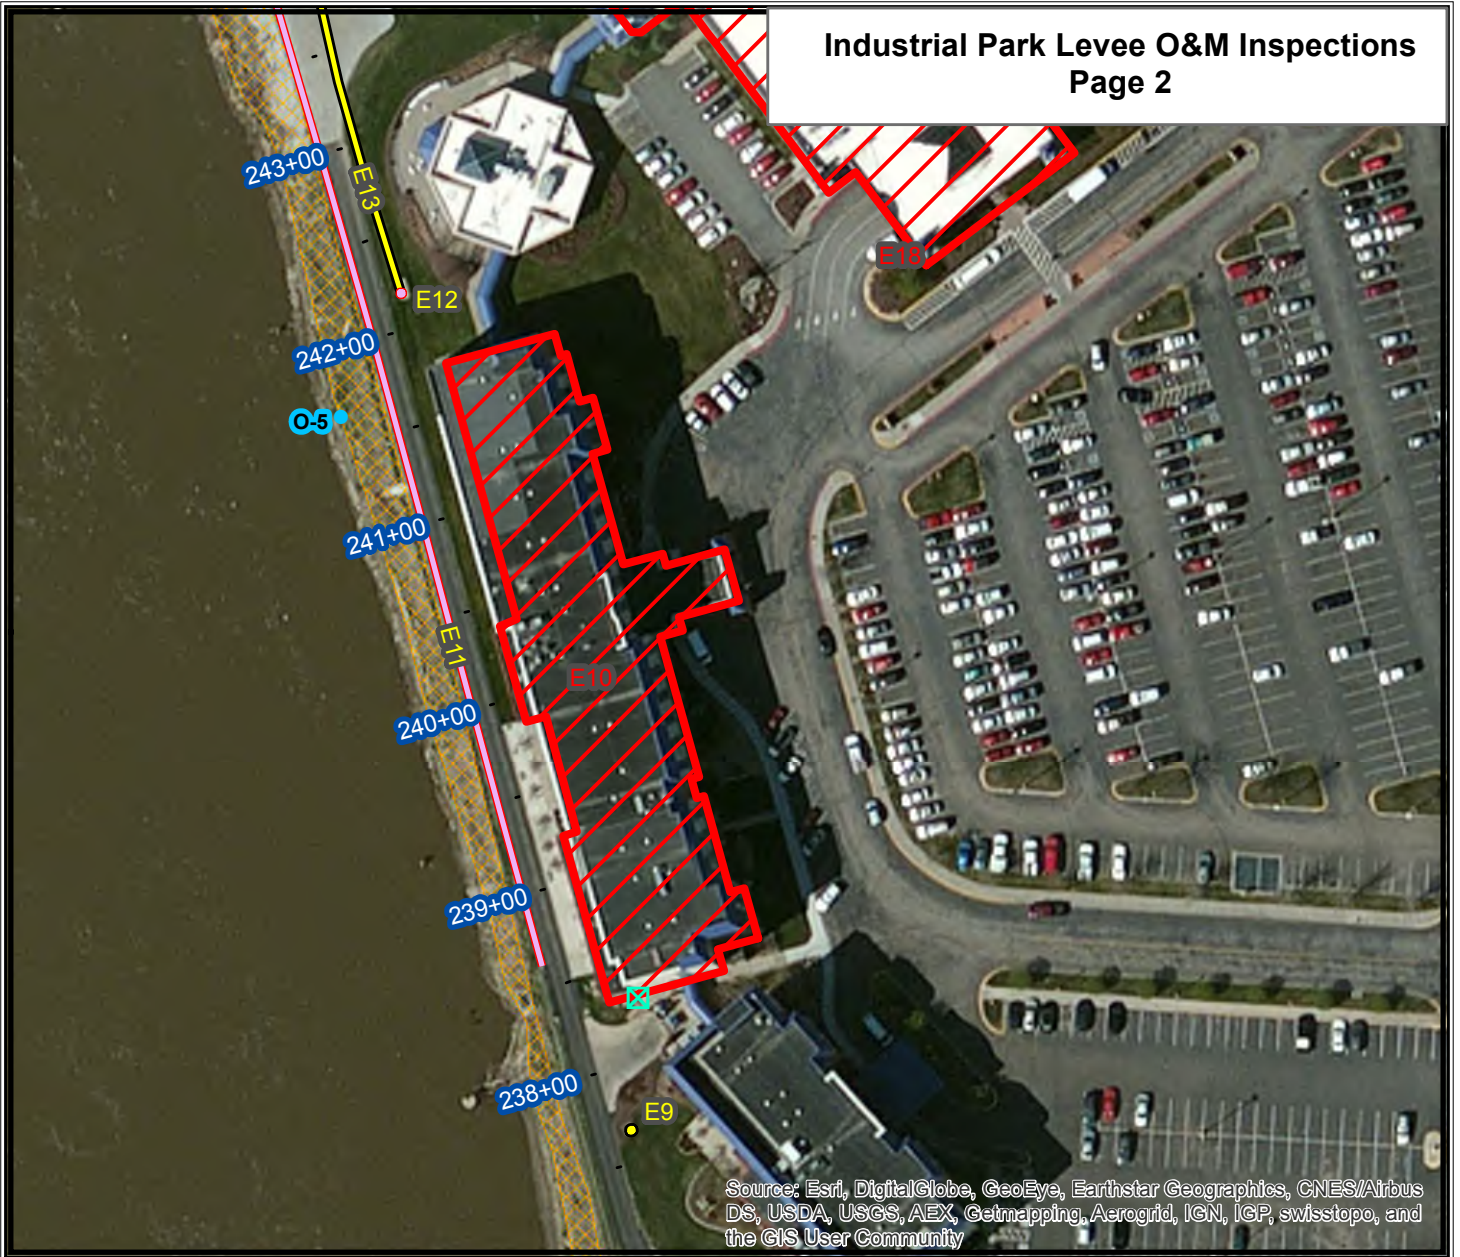
# Industrial Park Levee O&M Inspections Page 2

- Outfalls
- ☒ Drainage Structures
- ⚡ Underground Encroachment\*
- ⚡ Above ground Structure (Encroachment\*)
- 🔲 Building Encroachment\*
- 🔲 Riprap
- 224+00 IPL Station
- Outfall ID Outfall ID

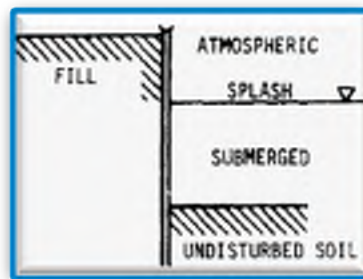
- Corrosion is most commonly found in the atmospheric and splash zones as depicted below. It is important to note that not-exposed sheet wall components are also at great risk for corrosion; these zones include “Submerged” and “Undisturbed Soil.”

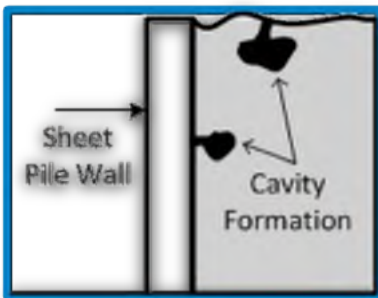
- Depressions or settlement on backfill surface
- Holes or apparent burrows on backfill surface or on sheet pile wall
- Note what the surface condition is at the location of the settlement
  - Is the backfill supporting a structure?
  - Is the backfill surface paved or has a sidewalk?
  - Is there nothing on the backfill surface?

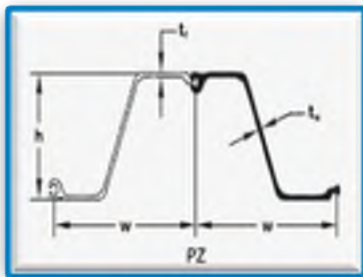
- An intact interlock should appear as the image below:

- Gaps between adjoining sheet will sections
- Interlocks that appear to be broken
- Corroded interlocks

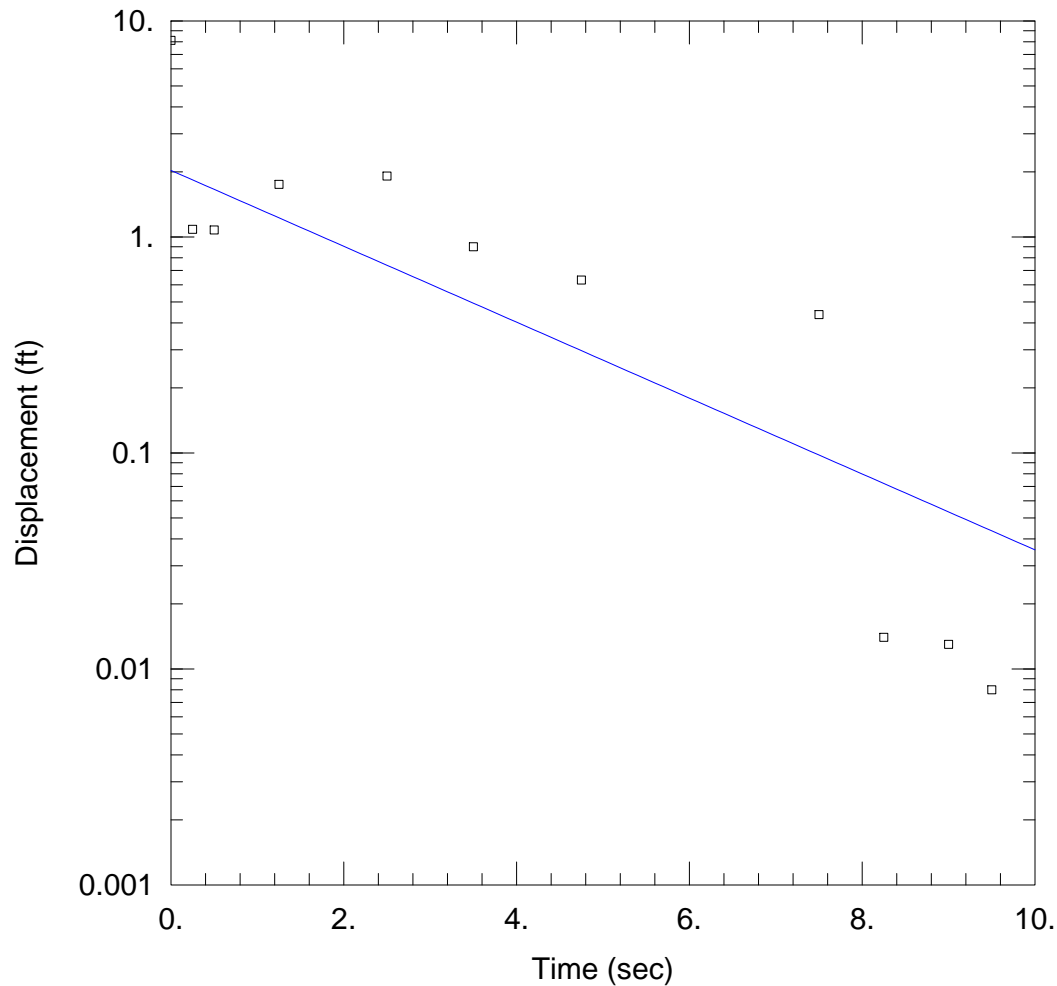
Aquifer Model: Unconfined Solution Method: Bouwer-Rice  
 $K = 0.0002368$  ft/sec  $y_0 = 2.032$  ft
